SAILPLANE ACCIDENT INVESTIGATION
COCKPIT DAMAGE REPORT

issue: June 15, 2006

The aim of this study is to improve pilot survivability and protection from injury in sailplane accidents.

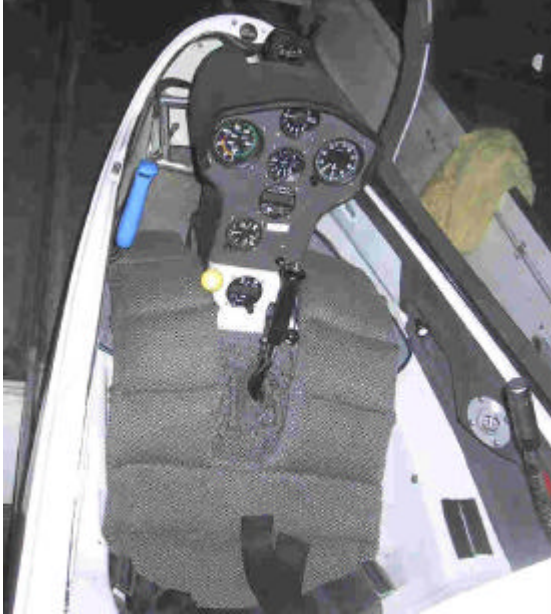
Forward seat and legs room

to show damage to cockpit structure, instrument panel, leg room and pedals, sharp edges, belts/harness, seat cushions.

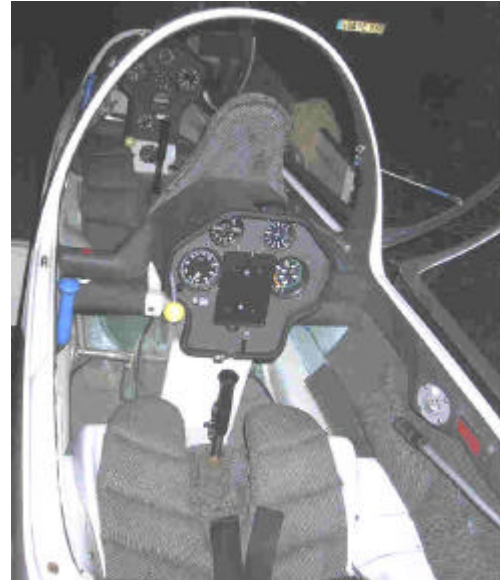
Rear seat and legs room

to show damage to cockpit structure, instrument panel, leg room and pedals, sharp edges, belts/harness, seat cushions.

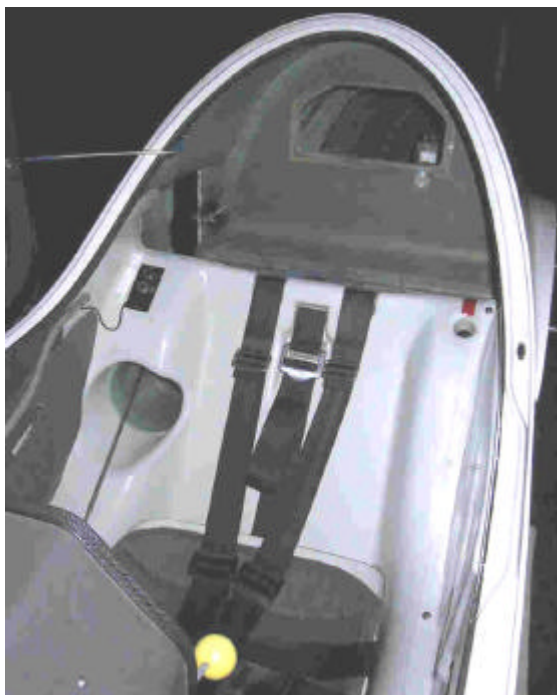
Rear seat backward view

to show damage to cockpit structure, belts/harness, anchor points, back rest, head rest, sharp edges, seat cushions.

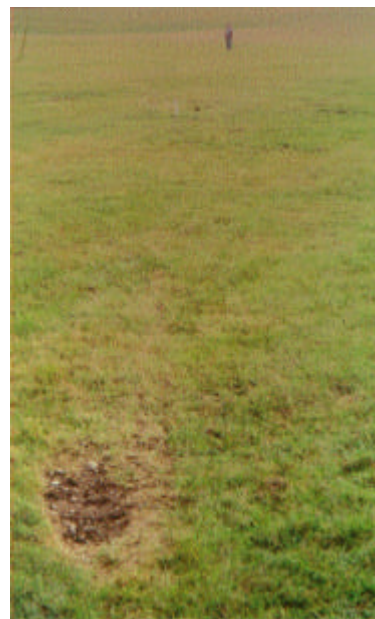
Impact mark

to show impact site with impact mark in foreground and indication of final cockpit position in background.

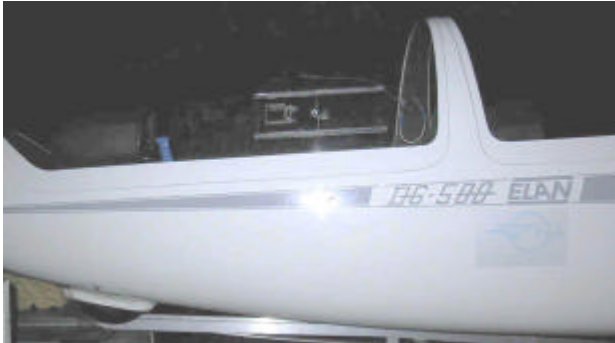
Left hand side (flight direction)

to show the amount of damage or prove of no damage on the left hand side of the sailplane.

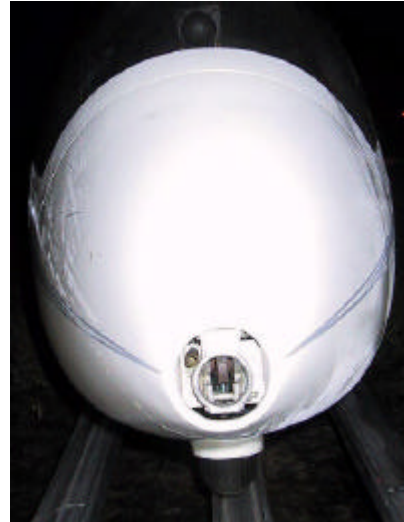
Front

to show the amount of damage or prove of no damage to the sailplane's front.

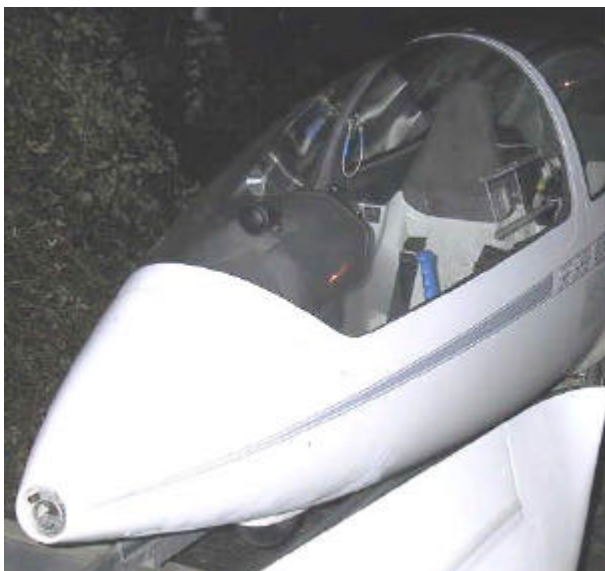
Left fuselage nose (flight direction)

to show the amount of damage or prove of no damage on the left front side of the sailplane.

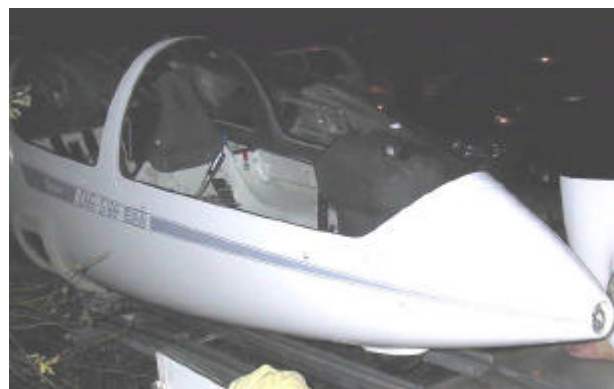
Right fuselage nose (flight direction)

to show the amount of damage or prove of no damage on the right front side of the sailplane.
